## Evaluation of Spinal Stability

### Clinical Case Overview

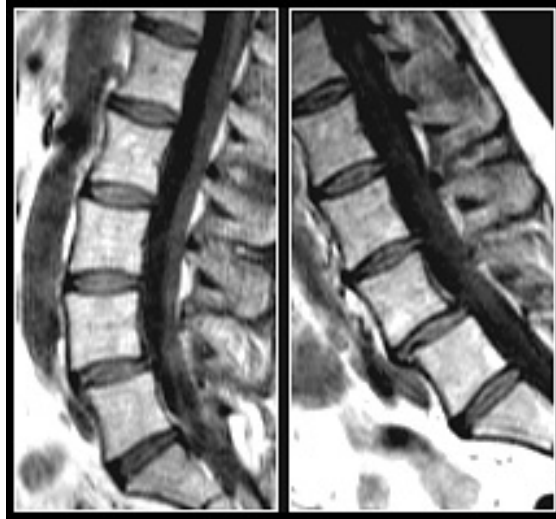
The recumbent scan (left) demonstrates minor degenerative anterolisthesis at L4/5. The upright-flexion study (right) reveals further anterior slip of L4 on L5. These scans show hypermobile translational spinal instability, which can be a surgical indication in a case of related low back pain.
