Position-Related Recurrent Disc Herniation

Clinical Case Overview

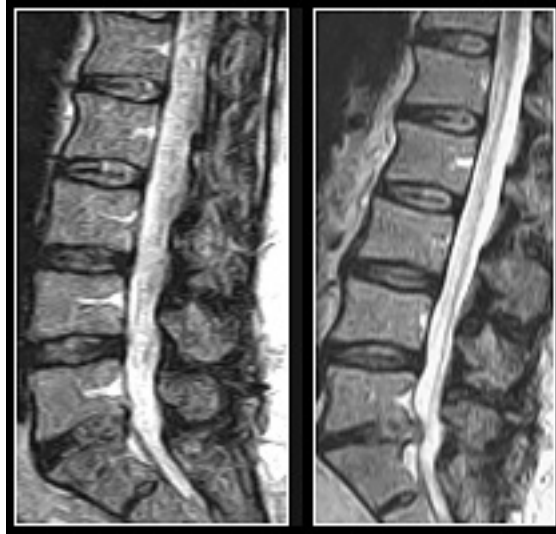
The recumbent scan for this patient with right-sided radiculopathy following partial discectomy is shown on the left. The upright scan (right) shows a disc herniation at L5/S1.
